# ATLAS Safety Bulletins

## Near-miss Case Studies

## 1. Industrial Chimney Inspection

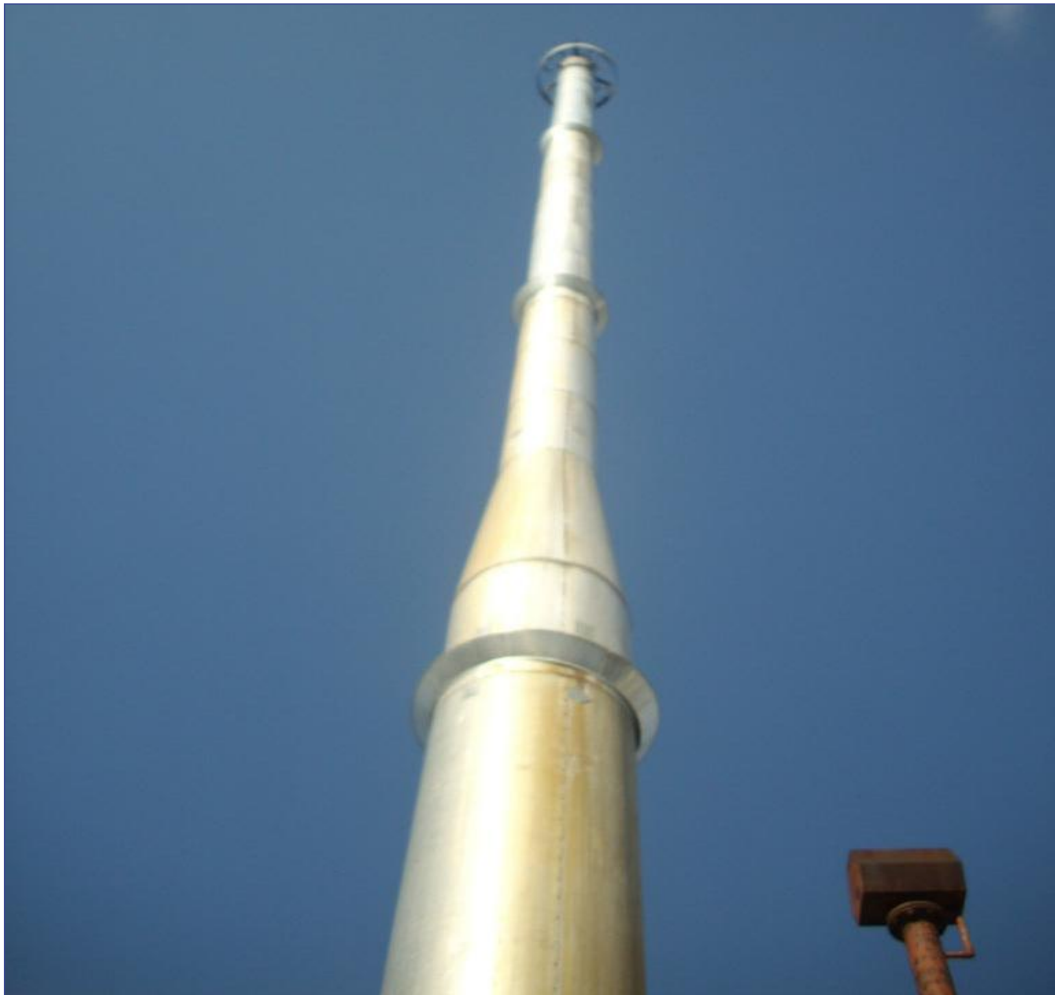
The 36.0m tall chimney prior to the inspection - fully clad and insulated

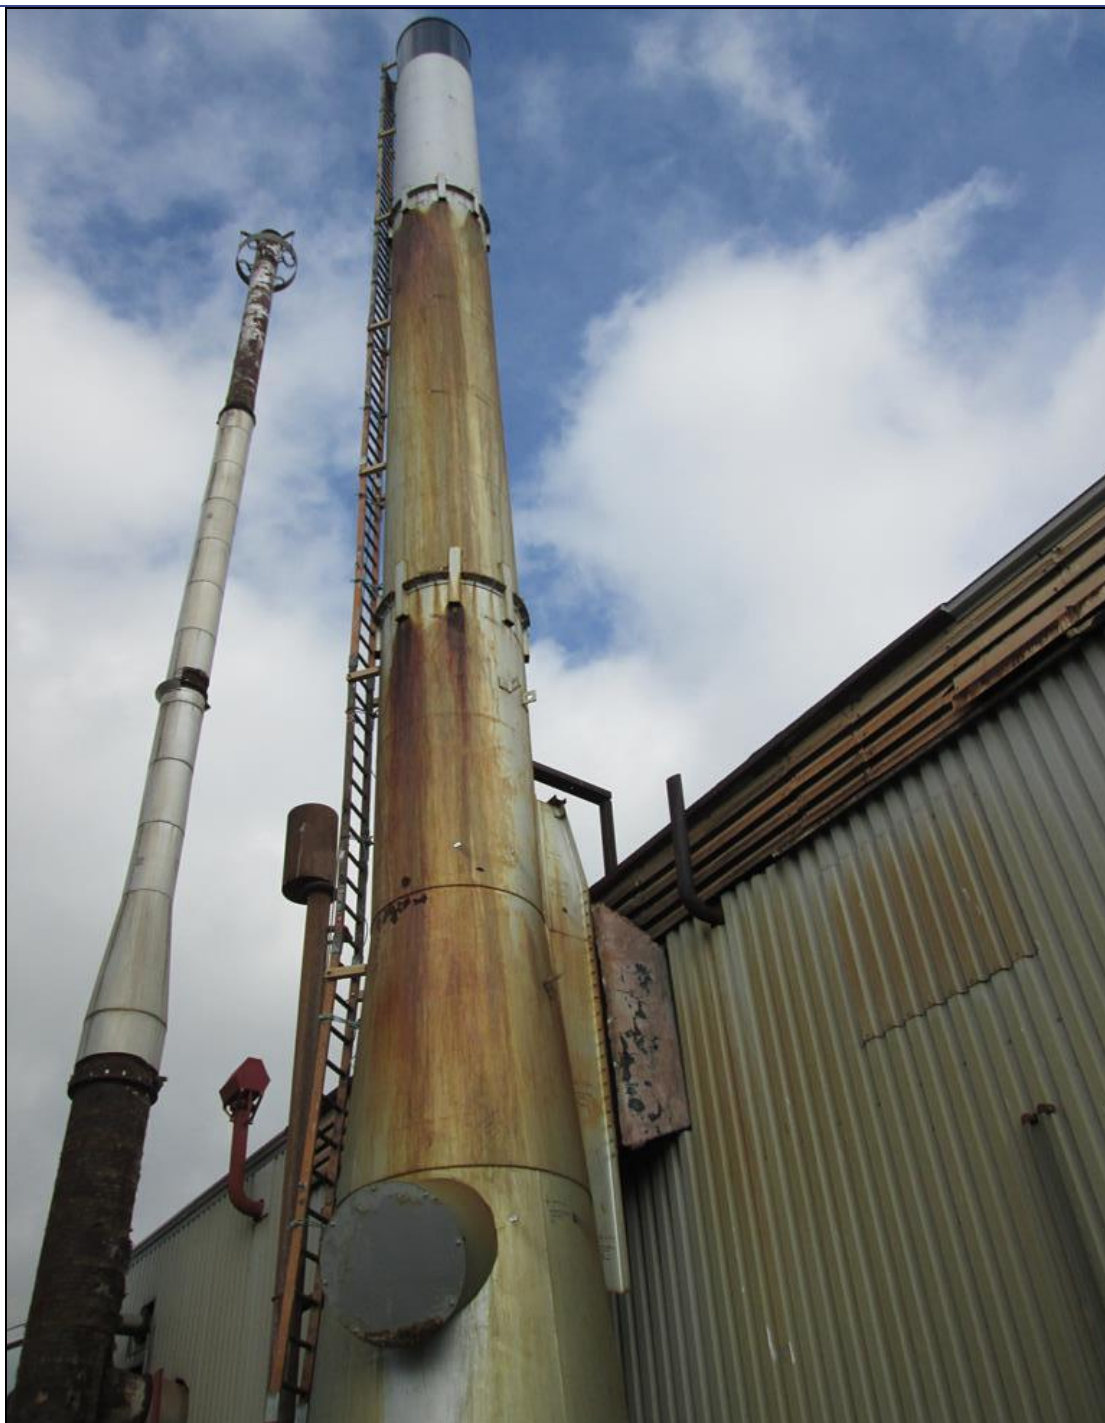
The chimney in question can be seen in the background with sections of the insulation and cladding removed.

The chimney nearest has been inspected using powered access and deemed to be structurally sound. Steeplejack ladders together with fall arrest systems have been installed to facilitate the undertaking of remedial repairs and painting work to this particular chimney.

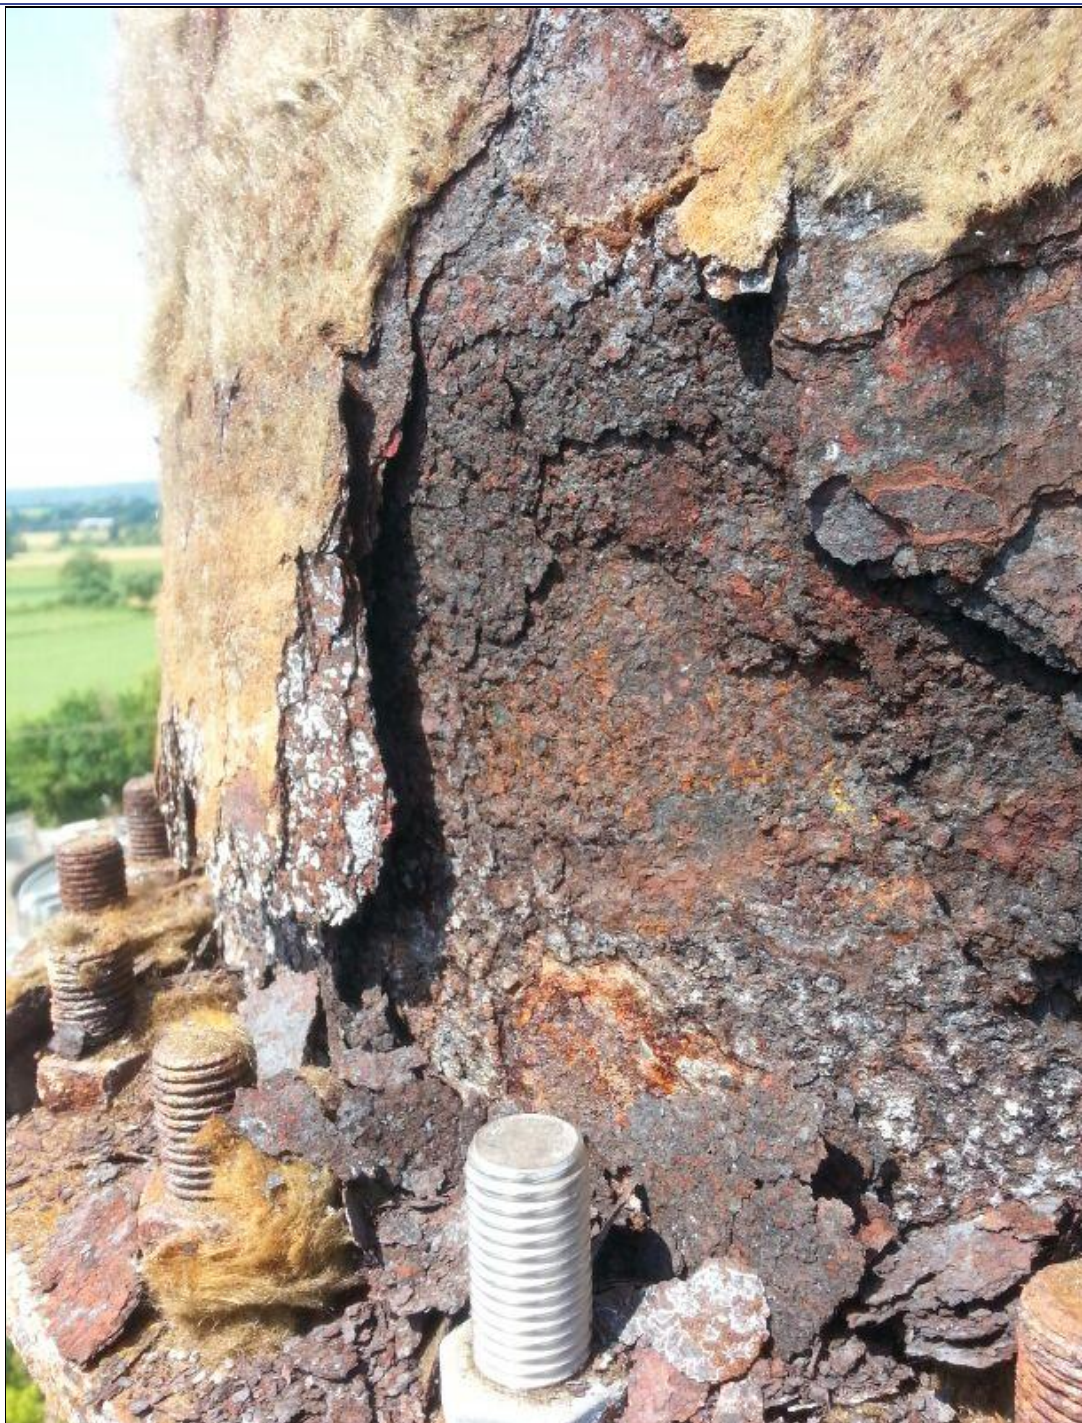
Following the removal of the insulation and cladding, extensive loss of the structural steel plate thickness was revealed immediately above the top two bolted flange connections. This loss of steel thickness had completely compromised the structural stability of the chimney. Mobile cranes were brought to site and the top two chimney sections were safely removed.

Advanced corrosion at the top flange – structural walls were found to be paper thin.

There will always be a requirement for steeplejack access methods when inspecting and working on chimneys and tall structures. However when planning industrial chimney inspections, the HSE's Hierarchy of Risk should always be applied, and where it is identified as being feasible and practicable to do so, powered access should always been employed as oppose to laddered and rope access for inspections.

Insulated and clad steel chimneys represent one our industries biggest safety concerns, often corrosion and structural defects are hidden from view. For this reason alone access that is not directly attached to the chimney being inspected should always be the access of choice i.e MEWP or Crane & man riding basket.

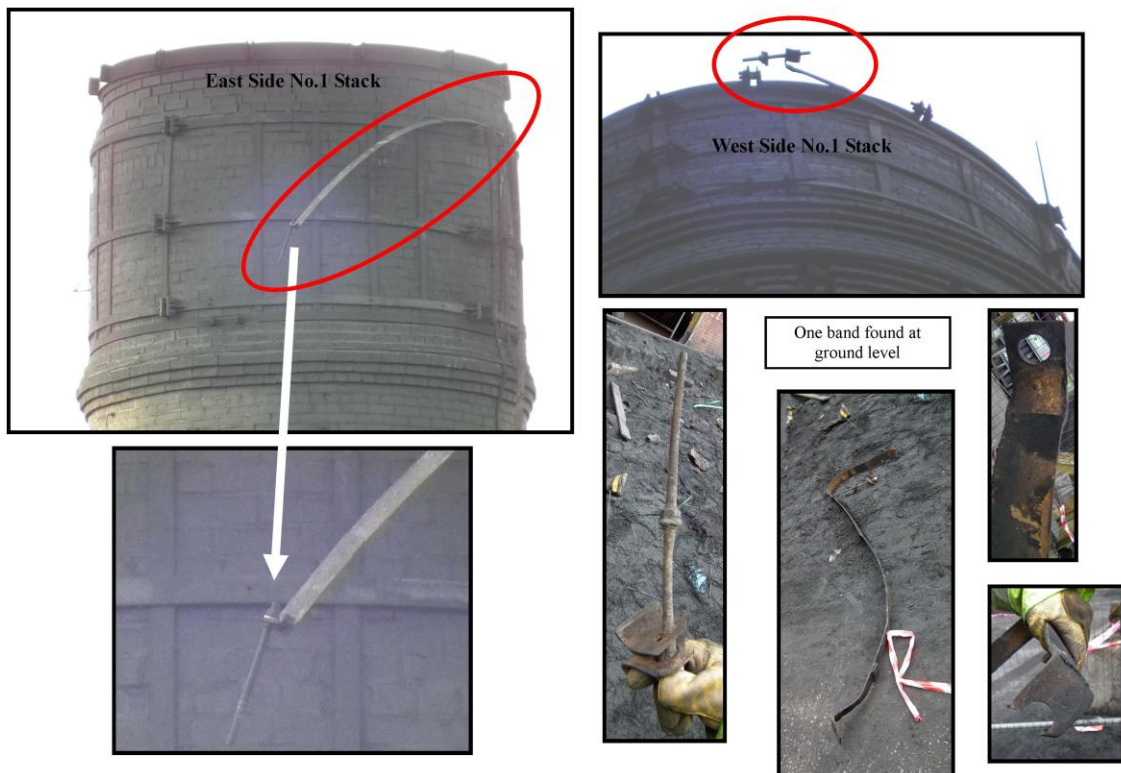
An ATLAS member company was recently contacted by a client reporting that a steel band had broken free from the summit of a brick chimney. Unfortunately the dangerous state of the structure, combined with poor weather conditions, prevented the steel band from being removed in a controlled manner and sections of the band fell to the ground from a height of 75m.

The failed steel band

This should serve as a stark reminder to all companies engaged with laddering chimneys that unless a survey has been completed prior to the installation of ladders using powered access, fixing ladders directly to steel bands should never be encouraged.

ATLAS encourages its members to refer to the recently published laddering guide and if a decision to fix ladders directly to steel bands is considered, this decision should only be taken once all steel bands have been thoroughly inspected and deemed to be in a good structural condition and if necessary their suitability confirmed via calculations.

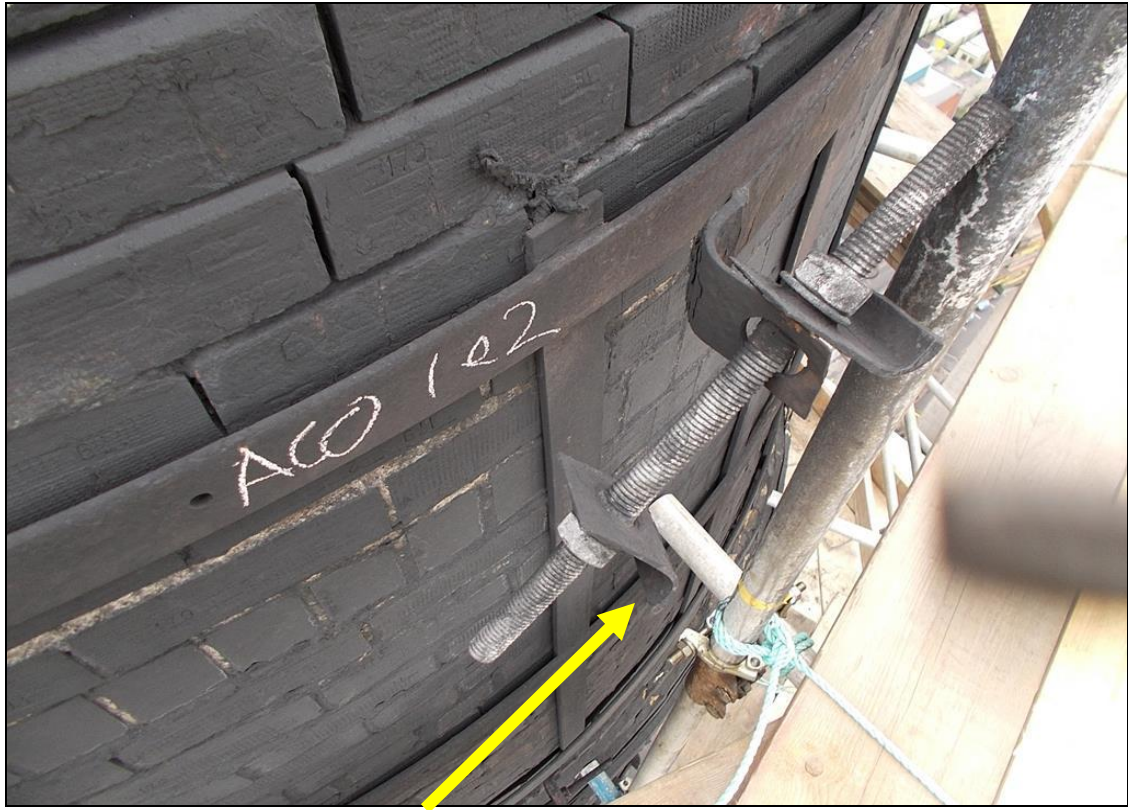
Location where the band had failed

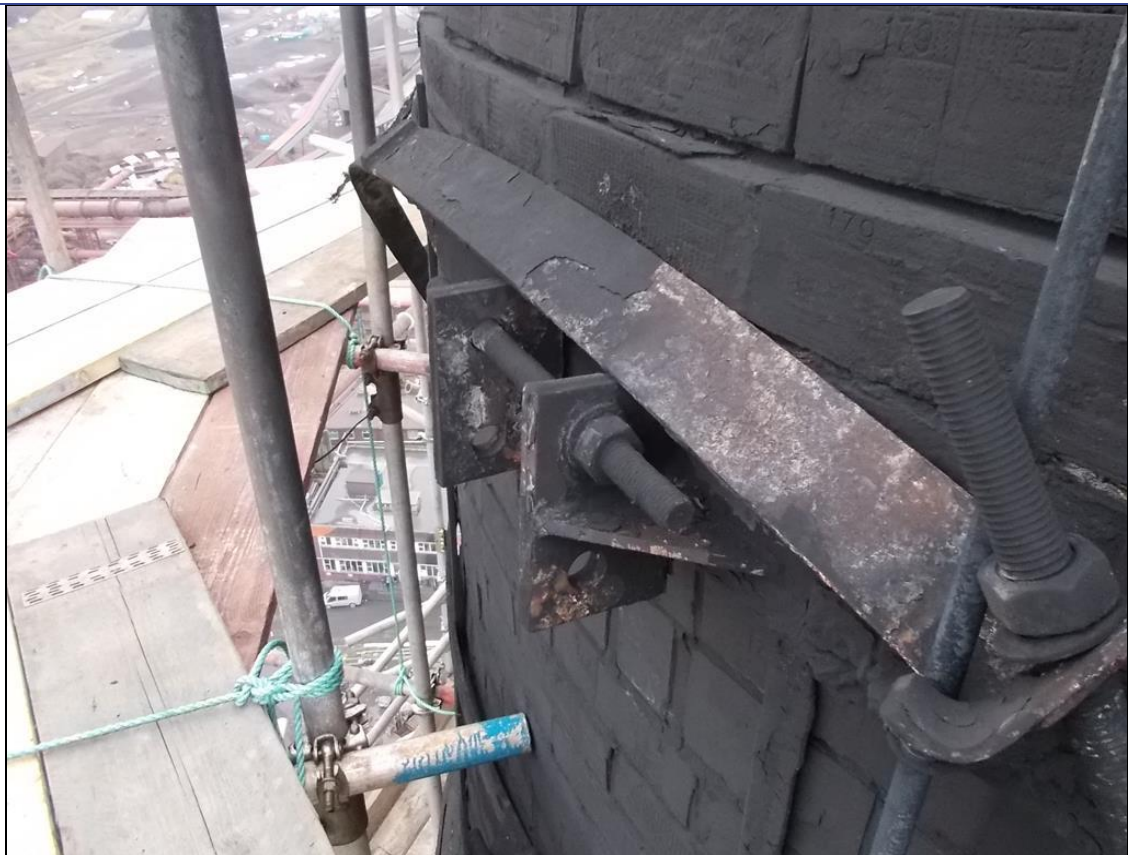
Sections of the band lodged behind a lightning conductor air terminal

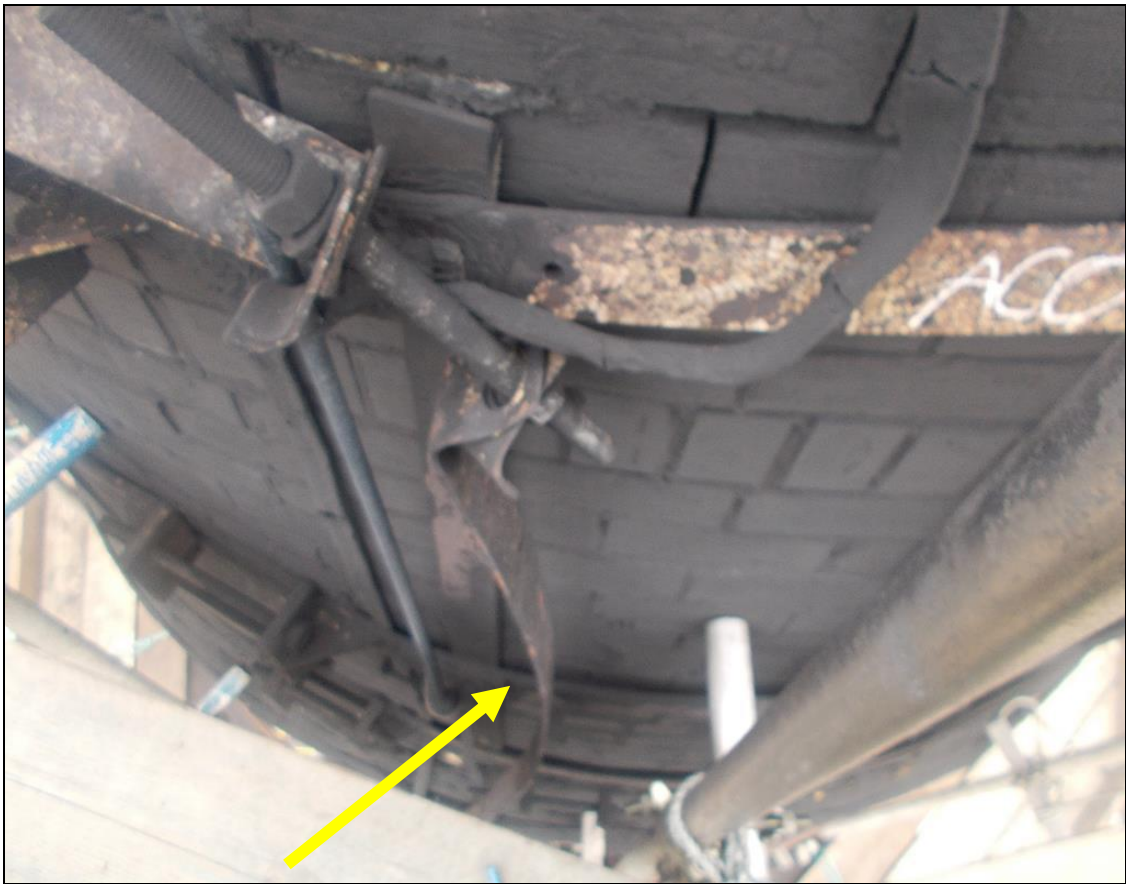
Section of the band left hanging

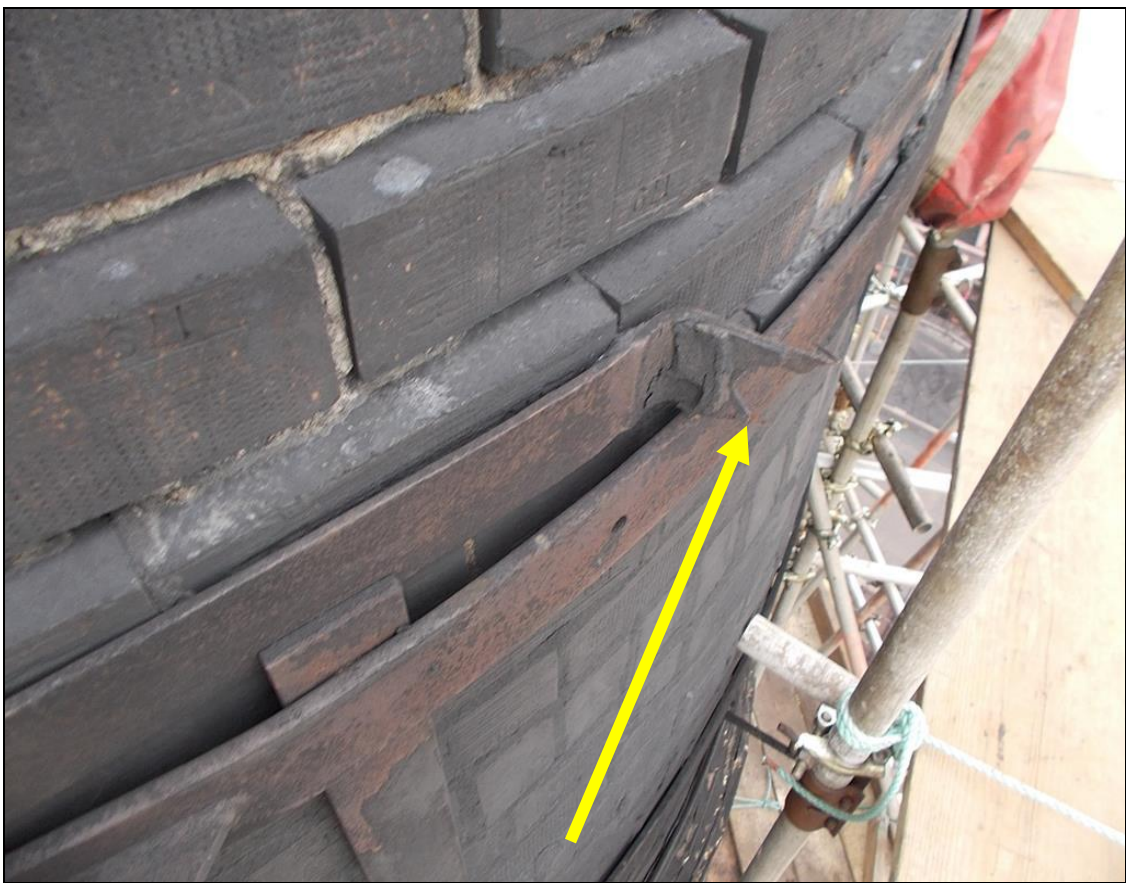
Section of the failed band stuck behind other steel work

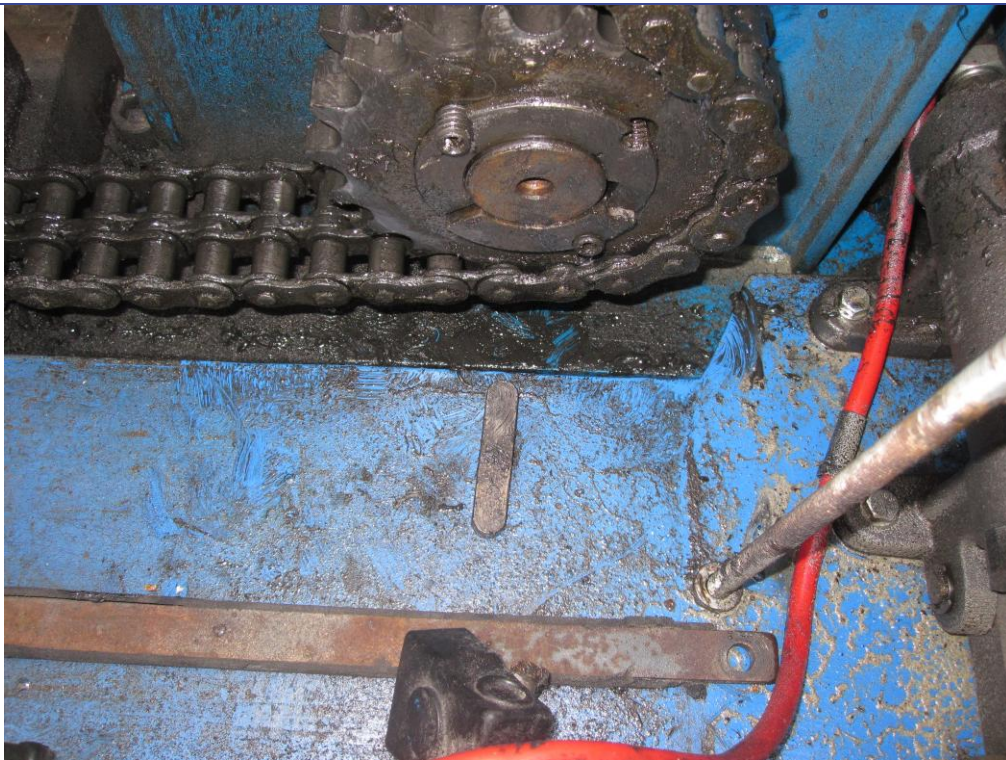
The rear cog detached from the spindle and the woodruff key worked loose. A mechanical failure of the Taper Lock prevented the spindle staying engaged with the cog.

The failure of the Taper Lock caused the uncontrolled descent. It has highlighted the need for more checks to the arrangements on the winches that could cause a failure. The

The winch has a secondary braking device which is activated by the operator releasing the control lever (dead man's handle) back into the neutral position. Unfortunately this incident happened so quickly that the operative did not have time to react quickly enough, and the lever remained in descent position, resulting in the secondary brake not activating.

**If any member companies are operating Thompson 21/60 diesel winches, we recommend that you have them checked with the manufacturer for the Taper Lock arrangement and any other item that could cause failure.**

**Ensure your operators are trained and are aware of the release of the control lever back into neutral.**
